## GEOTECHNICAL INVESTIGATION

Bank Stability Assessment  
Fitzroy River, Garnant

Report for: Alluvium Consulting Pty Ltd  
23332-002-Rev0  
29 November 2023

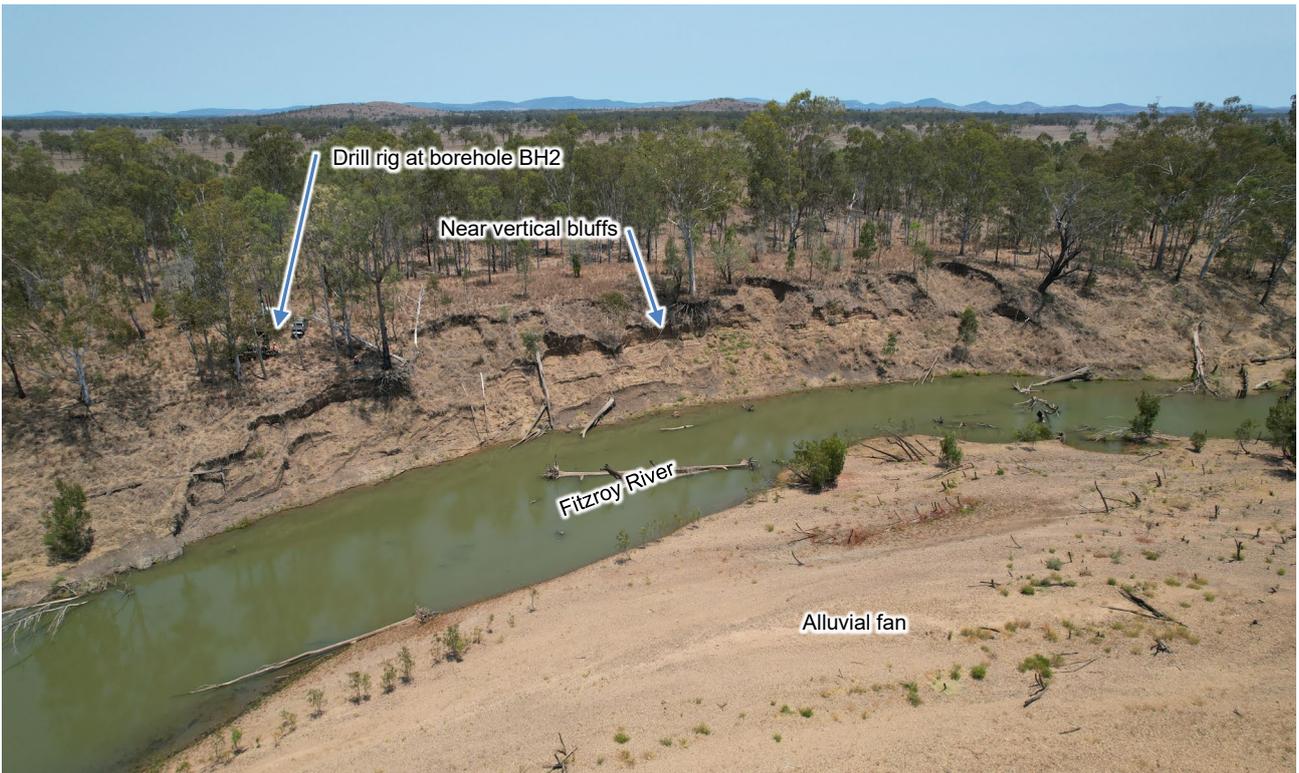
The banks along the site featured a range of geometries, with significant evidence of erosion and previous bank slumping observed consistently, and debris fields present in multiple sections along the riverbed.

Generally, there was a near vertical upper bluff estimated to range between about 1 m and 7 m high developed beneath the crest, with slumped debris forming a lower bank estimated to range up to about 7 m high, which dipped into the river between about 35° and 45°. Materials exposed in the banks appeared to comprise mostly interlayered sandy clays and clayey sands. Irregular and overhanging crests were noted, with tension cracking observed behind the crest in the soil mass, which may cause the material to fail by 'sheeting off' the face and toppling from the crest. The overall height from the crest to the water surface was estimated to be in the order of about 14 m.

*Text Figure 2: Oblique drone view of the site, looking south*

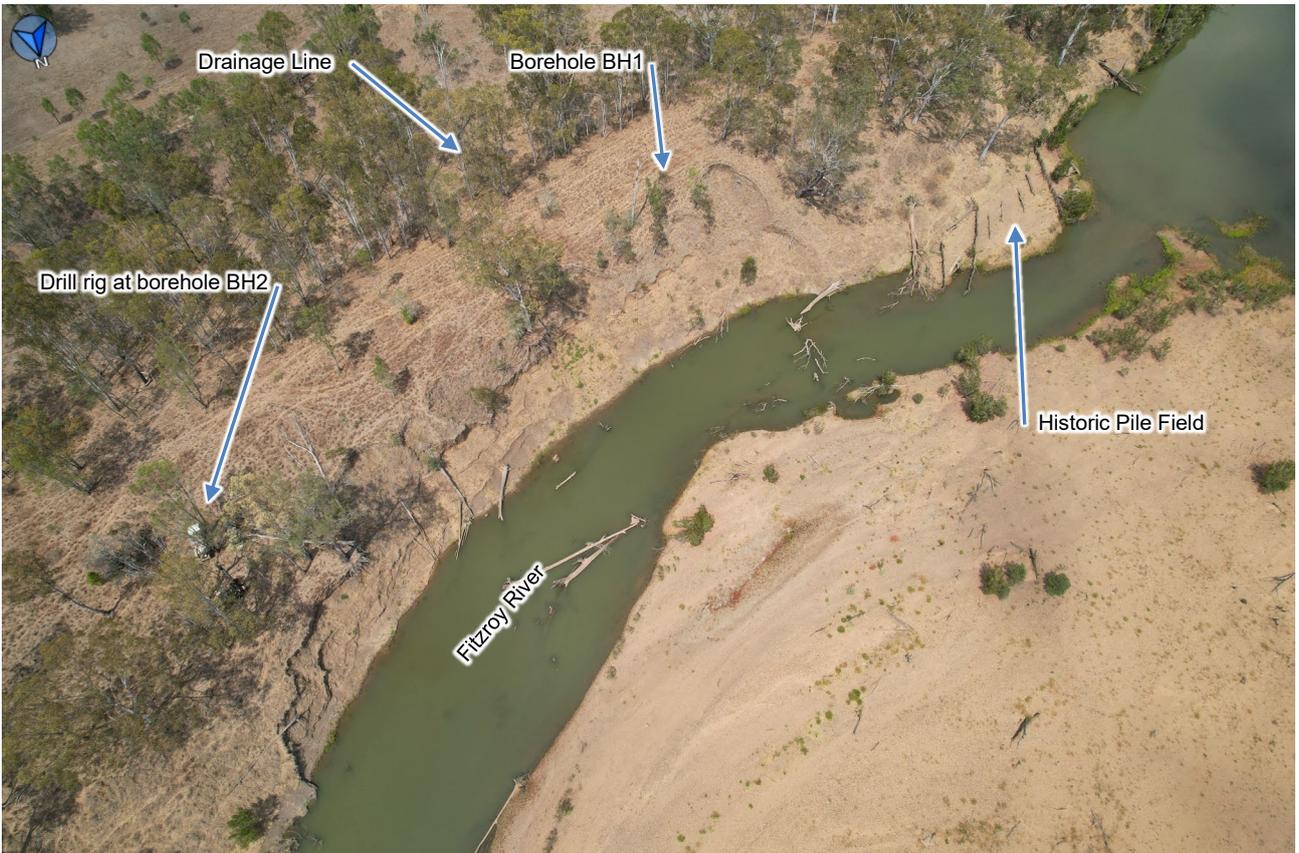
*Text Figure 3 Near vertical drone imagery shown the site*

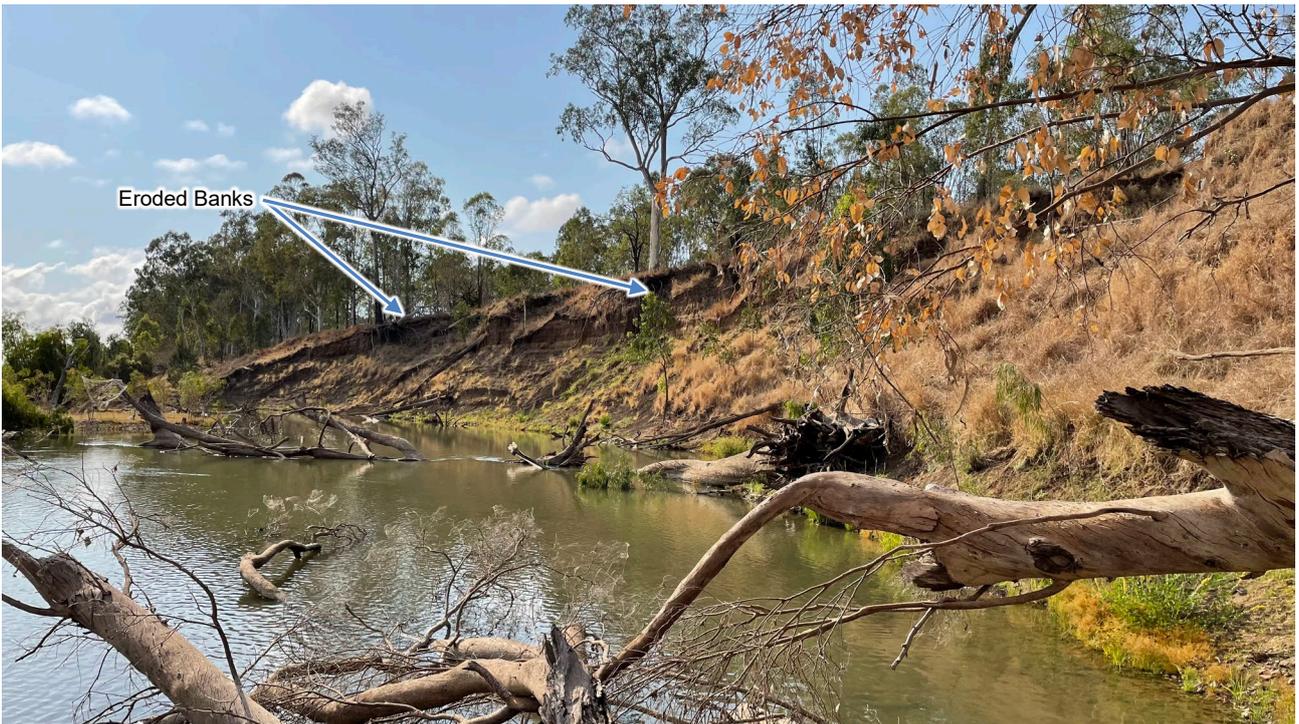
*Text Figure 4: Looking east along Fitzroy River from the western end of the site*

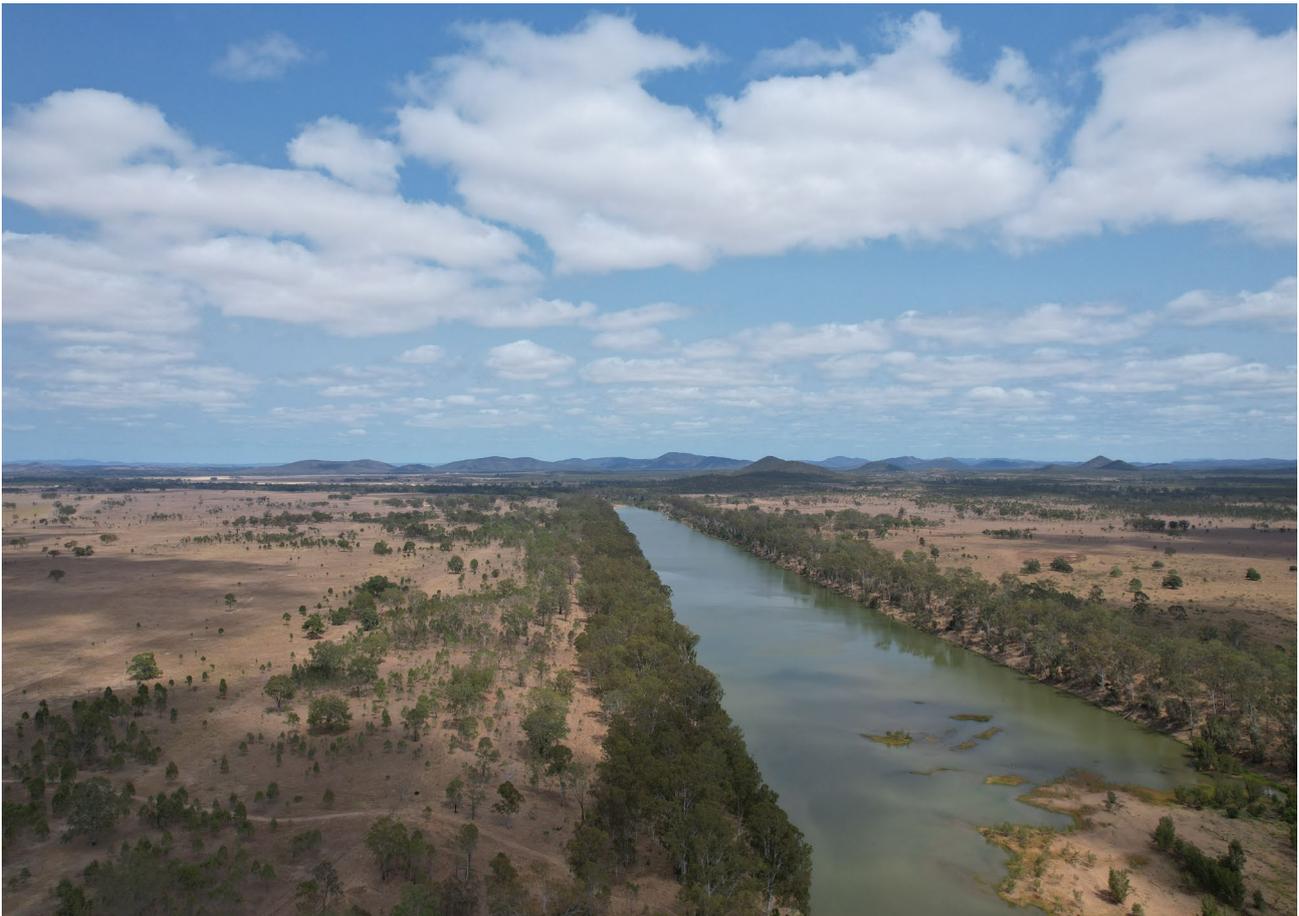
*Text Figure 5: Surrounding conditions, drone image looking west along Fitzroy River*

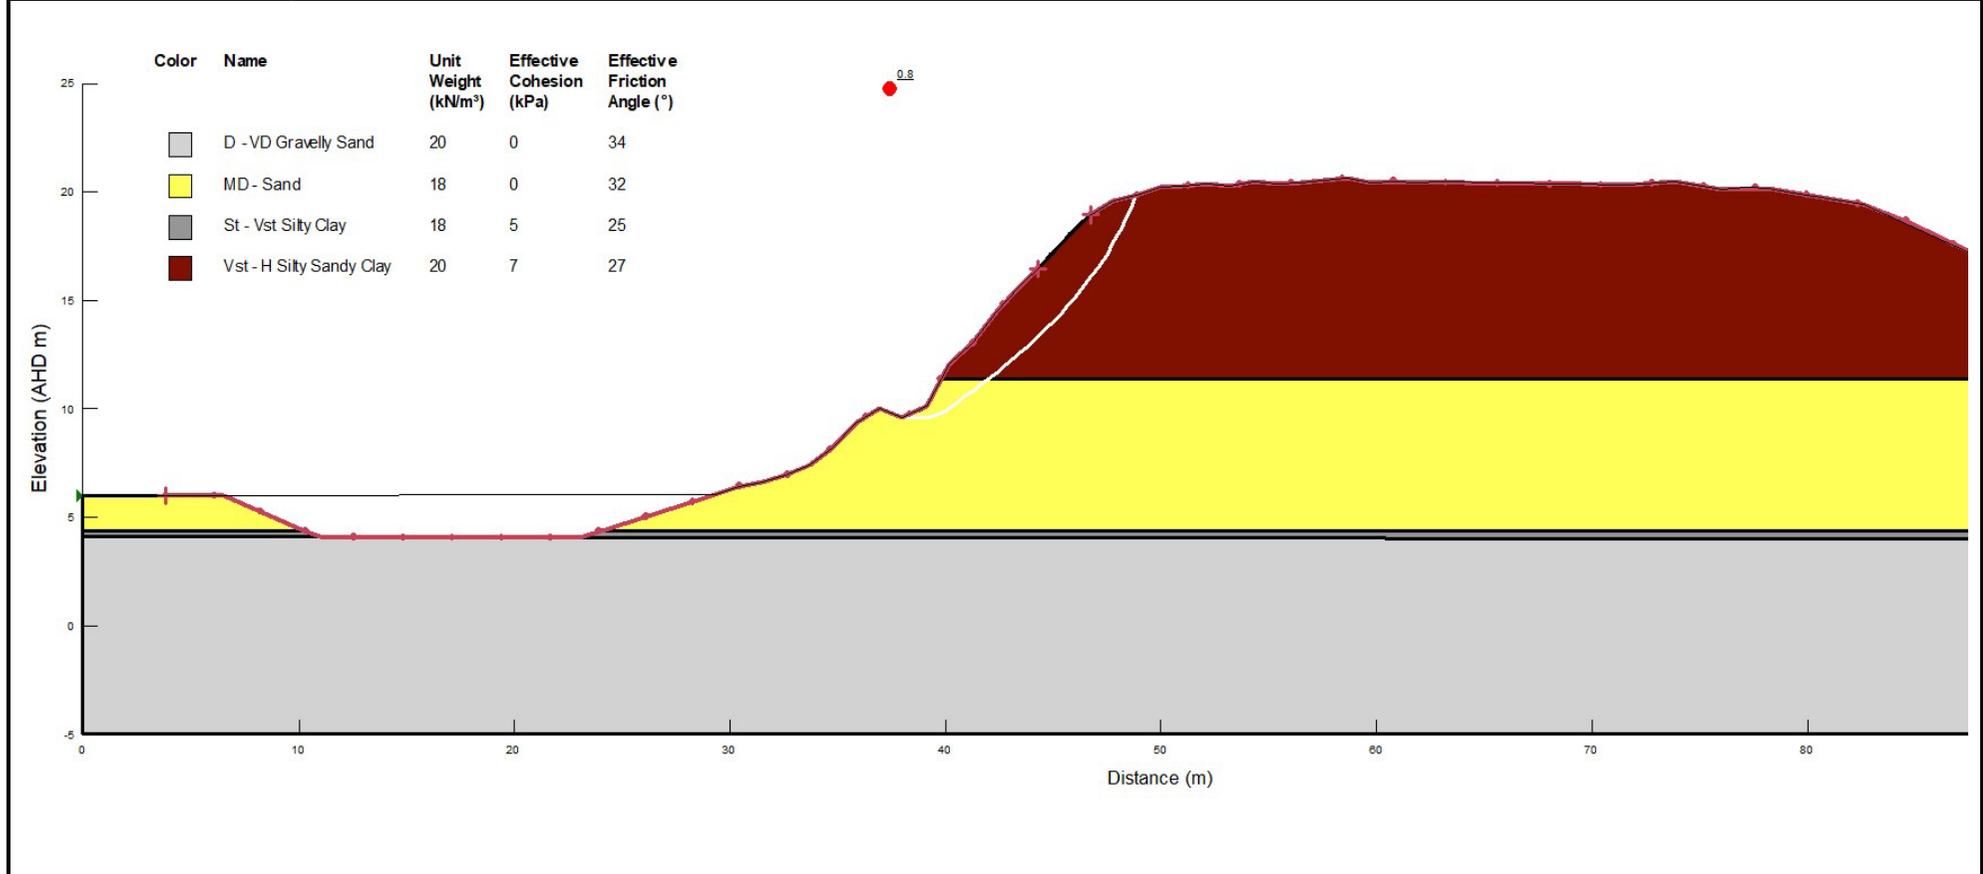
Project Name	Assessment of Bank Stability – Fitzroy River, Garnant
Project No.	23332
Report No.	23332-002
Title	Analysis 1 – Section A – A' - Existing Profile

For the existing profile, a FOS value of 0.8 was recorded which is expected given the observed failures of the existing banks in the investigation area. From a global stability perspective, the modelling indicates that the reprofiling of the banks and works proposed by Alluvium would result in a significantly increased FOS, in excess of 1.5, which is the commonly adopted industry standard for long-term conditions.

The cause of erosion and instability at this site appears to be due to scour of the alluvial soils, in particular the sands lower in the banks, from fast flowing river water (fluvial erosion) during high flow events, leading to undercutting and bank collapse. This would be particularly concentrated on the outside of bends in the meandering channel (where flow velocity and turbulence are typically greater). ECN and PSD testing indicates that the upper clay soils have low to moderate erosion potential. The combination of these adverse factors ultimately appears to have resulted in the instability of the riverbanks.

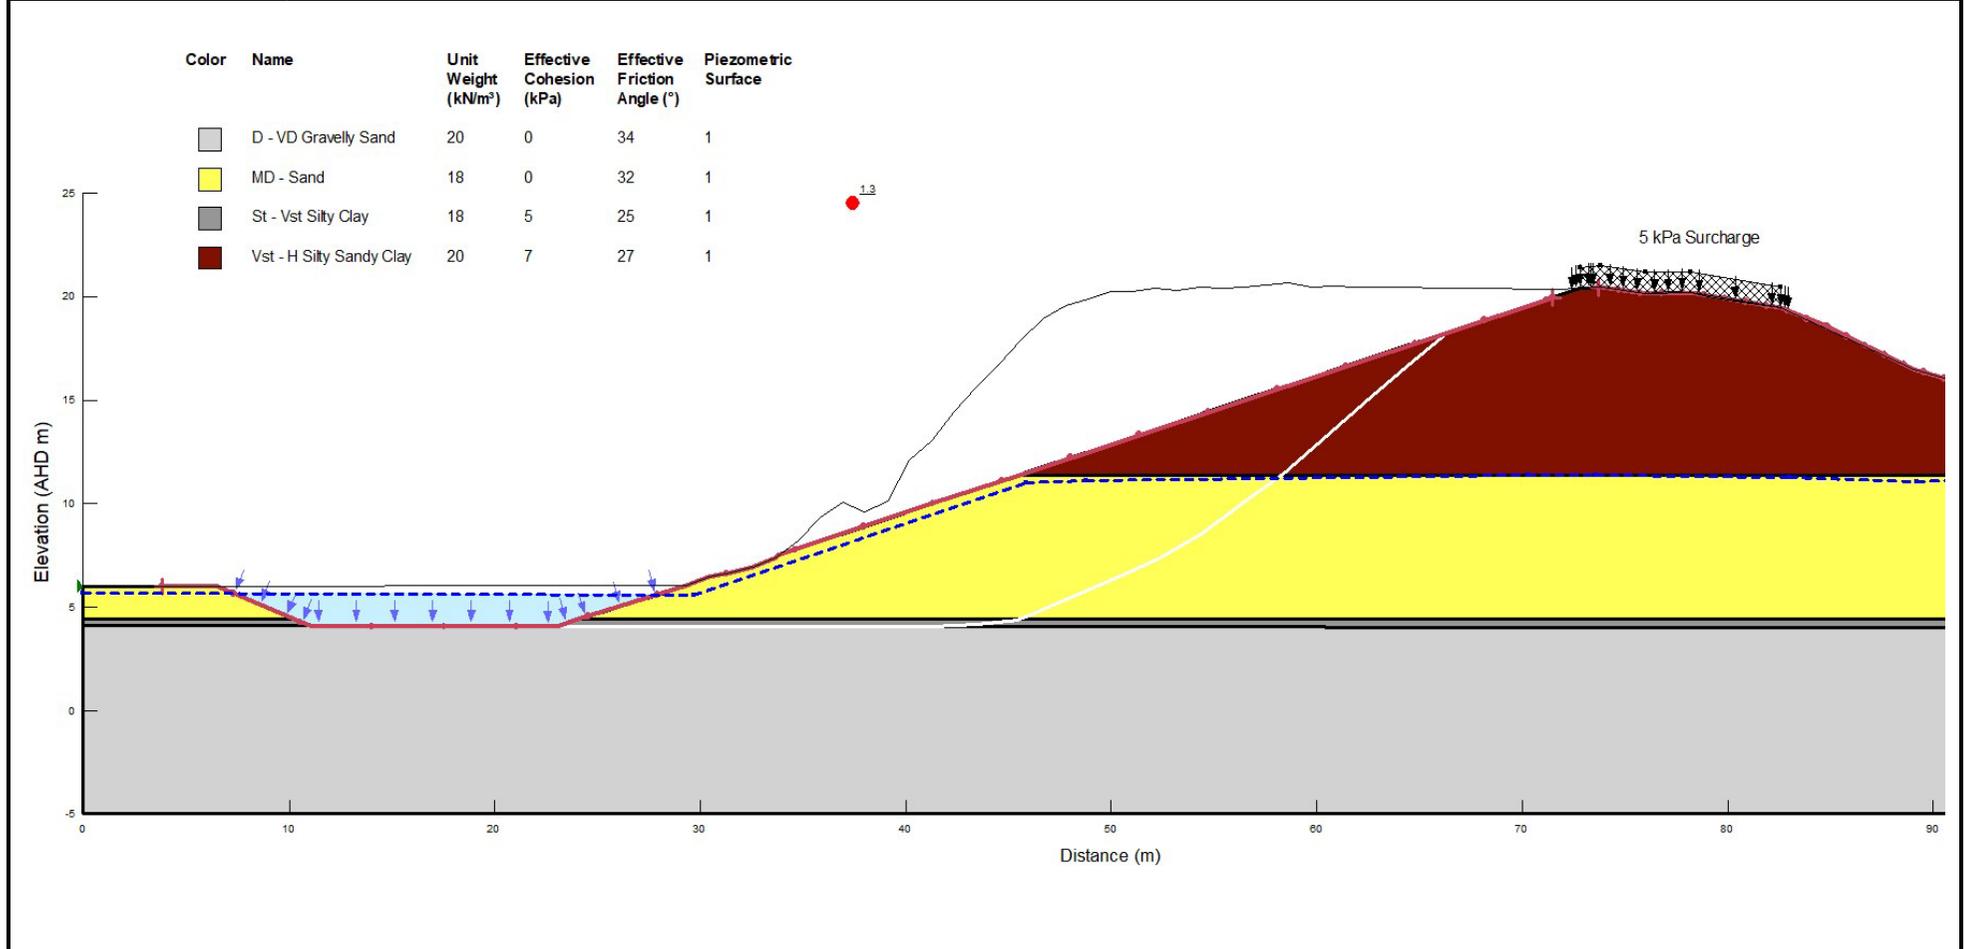
Project Name	Assessment of Bank Stability – Fitzroy River, Garnant
Project No.	23332
Report No.	23332-002
Title	Analysis 3 – Section A – A' - Proposed Cut Batter, Short Term Conditions (Drained Parameters)

Short-term conditions were modelled for an anticipated 'rapid drawdown' of the groundwater level following a flood event, resulting in an elevated piezometric line in the alluvial sands grading down to the approximate riverbed level. A FOS value of 1.3 was indicated from the modelling, being in line with the commonly adopted industry standard FOS value of 1.3 for short-term conditions.
