Hillview — Fitzroy

Gully Erosion

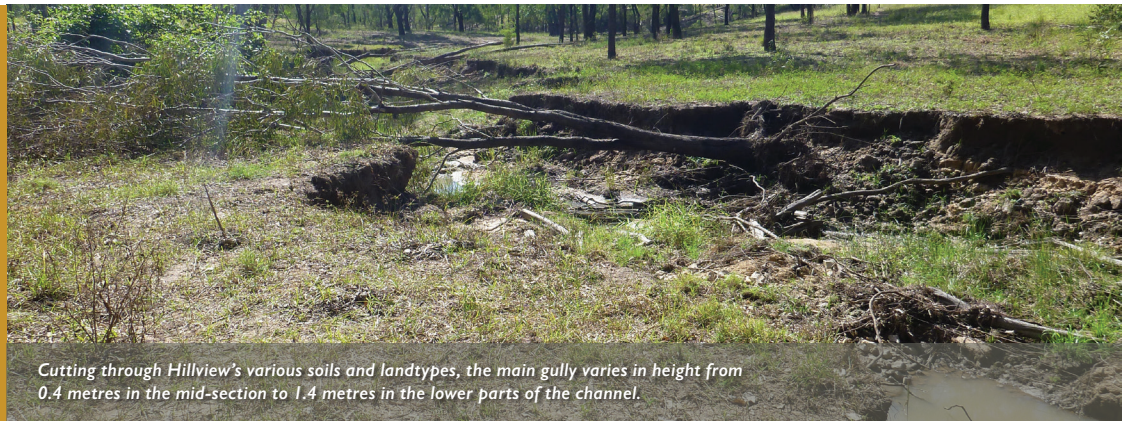
Cutting through Hillview's various soils and landtypes, the main gully varies in height from 0.4 metres in the mid-section to 1.4 metres in the lower parts of the channel.

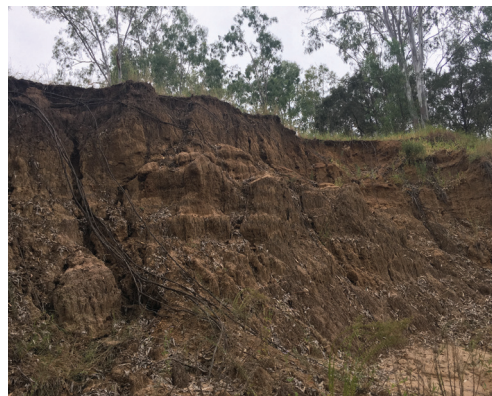
LEFT - BEFORE

Within the channel, patches of exposed, highly dispersive sodosols are interspersed between layers of sandy clay-loam.

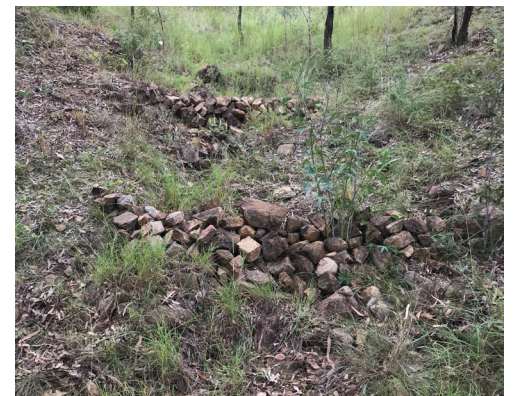
RIGHT - AFTER REMEDIATION WORK

In line with using local materials, rocks instead of the usual choice of sticks were chosen to create PCDs.

Following installation of the fences, porous check dams (PCDs) were constructed in the drainage lines north of the gully head in order to slow overland flow before reaching the gully.

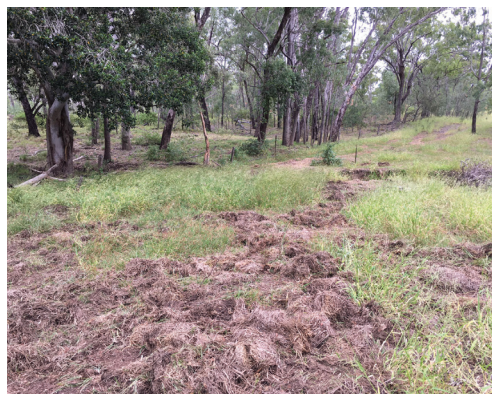
LEFT - AFTER REMEDIATION WORK

To enhance seed germination around the gully head, 15 round hay bales were also rolled out onto the contour for mulch.

Revegetation has been implemented across 3.1 hectares of the catchment adjacent to the gully head, and along the gully edges and floor to reduce the rate of head cut erosion, improve pasture condition and protect the property’s boundary fence. To provide favourable conditions for seed germination, the catchment was ripped in strips using Water and Soil Conservation Appendages (WASCAs; special

tynes which can be attached to a tractor). Given the soil fragility and sodic subsoil found just 20-30 cm below the surface in box flats country, Matt was careful not to penetrate the surface too deeply with the WASCAs. After ripping and mulching, Matt sowed an appropriate 3P (productive, perennial and palatable) pasture mix to establish a more resilient ground cover and out-compete undesirable Indian couch.

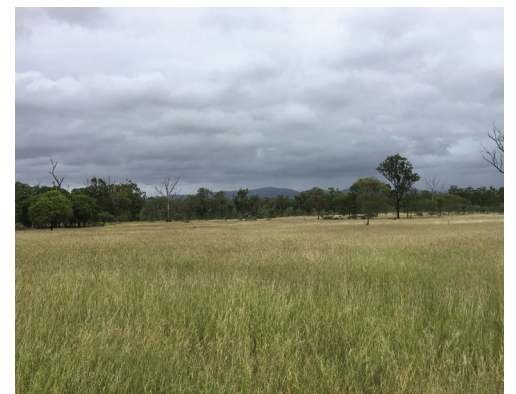
RIGHT - AFTER REMEDIATION WORK

Five months on, exclusion areas are already starting to grass up and the ripped country is going to seed.
