Junee — Mackenzie

Gully Erosion

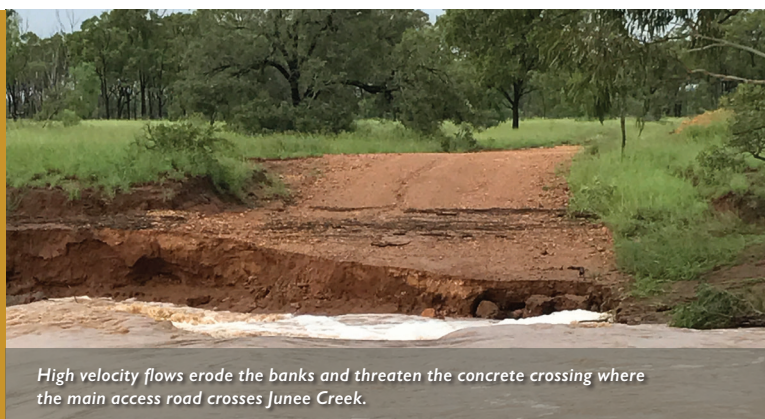
High velocity flows erode the banks and threaten the concrete crossing where the main access road crosses Junee Creek.

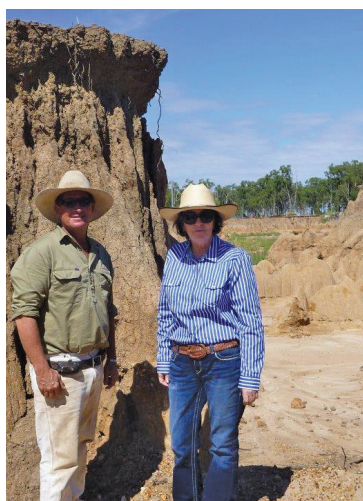
SITE 1 - BEFORE

This five hectare area contains two deep (mostly >2.5m in depth) gullies with steep, undercutting walls.

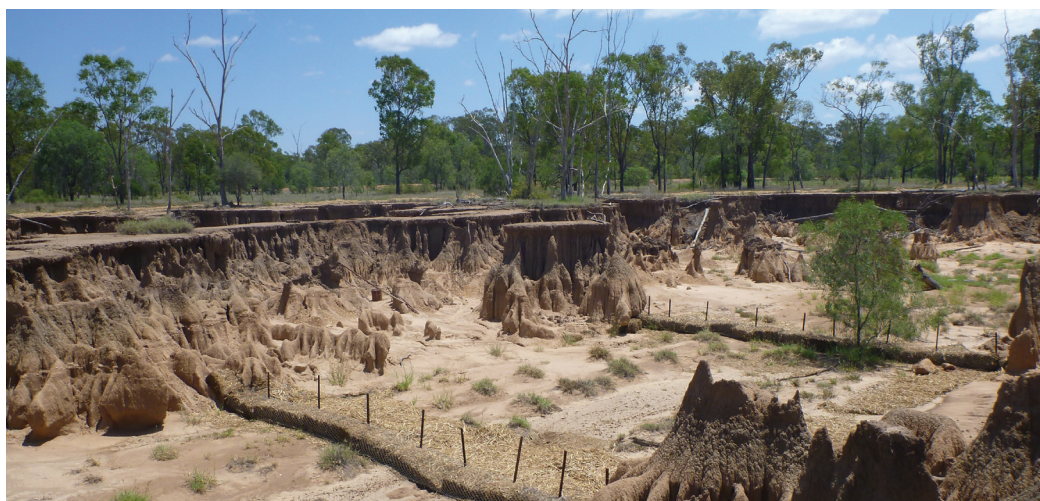
SITE 1 - AFTER REMEDIATION WORKS

Porous check dams (PCD's) constructed in the upper reaches of the two major gullies will aid sediment trapping on the gully floor to provide a more favourable environment for natural revegetation.

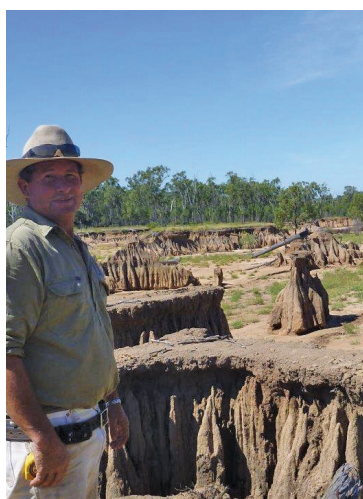
SITE 2 - BEFORE

Gully walls in this eight hectare area are similarly steep, although depths average approximately one metre.

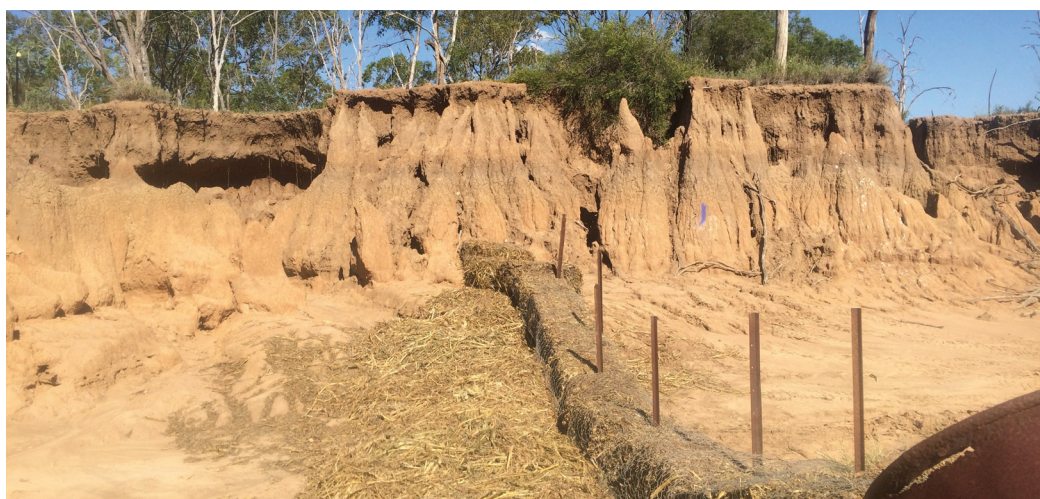
ALTERNATIVE MATERIALS FOR PCDs

Square hay bales are used instead of the recommended sticks to fill the PCDs given the amount of packing required to fill long PCDs and as a more effective trap for particularly sodic soils.
