Mt Ball — Theresa Creek

Gully Erosion

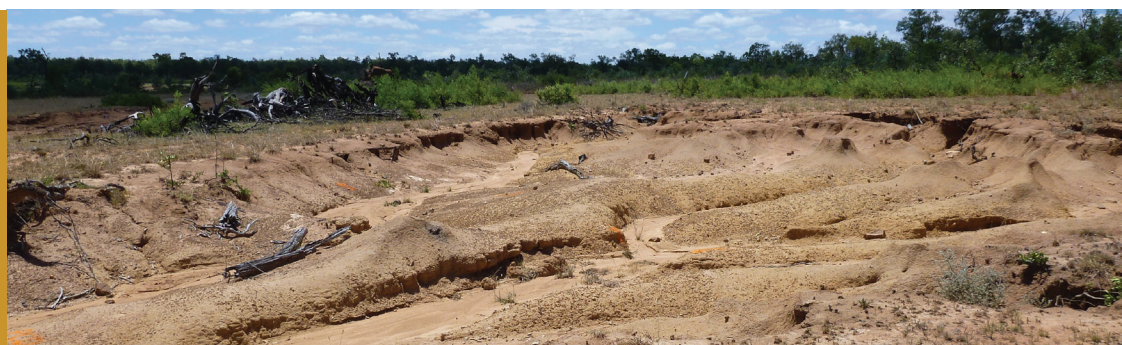
Site 1. A 2.4 hectare area of alluvial gully erosion along Carbine Creek, beside the old windmill and trough located in the corner of Carbine paddock.

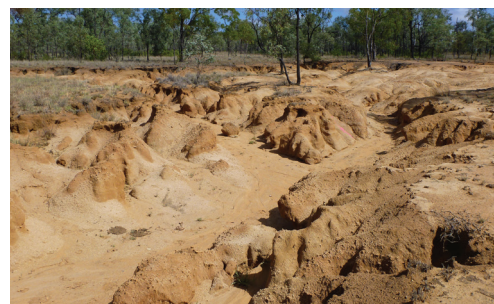
Site 2. A significant 20.5 hectares of similar erosion.

Based on historical imagery the erosion at Site 1 is thought to be the site of an old farm track heading directly upslope (another track has since been cut further east). Erosion at Site 2 is assumed to be caused by historical gem fossicking, preferential grazing and the installation of a windmill and watering point on the creek bank. Over time, cattle access between water and preferred grazing areas has compounded erosion at both sites resulting in a significant loss of top soil, leaving a hard-setting soil surface and exposed sodic subsoil.

At both sites, stock exclusion fences (0.6 km and 3 km) were installed, as much as possible, along the contours in each paddock to allow gullies to rest and recover.

In order to trap sediments and seed on gully floors and facilitate natural revegetation, Stuart constructed 31 Porous Check Dams (PCDs) using The Gully Toolbox guidelines.

Round hay bales were also rolled out on the hard-panned surfaces in and around gullies. With time it is expected that organic matter and sediments will accumulate in the hay allowing a variety of native grasses to establish.

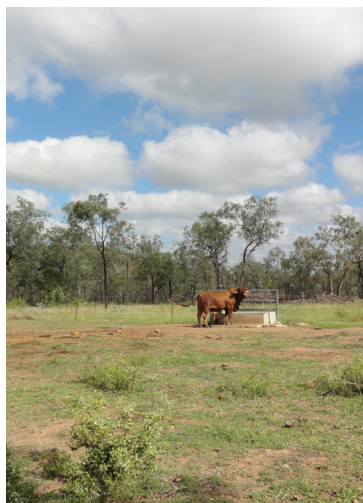
AFTER REMEDIATION WORK

To offset loss of water access in the erosion sites, two off-stream watering points have been strategically placed where they are least likely to lead to future erosion issues.

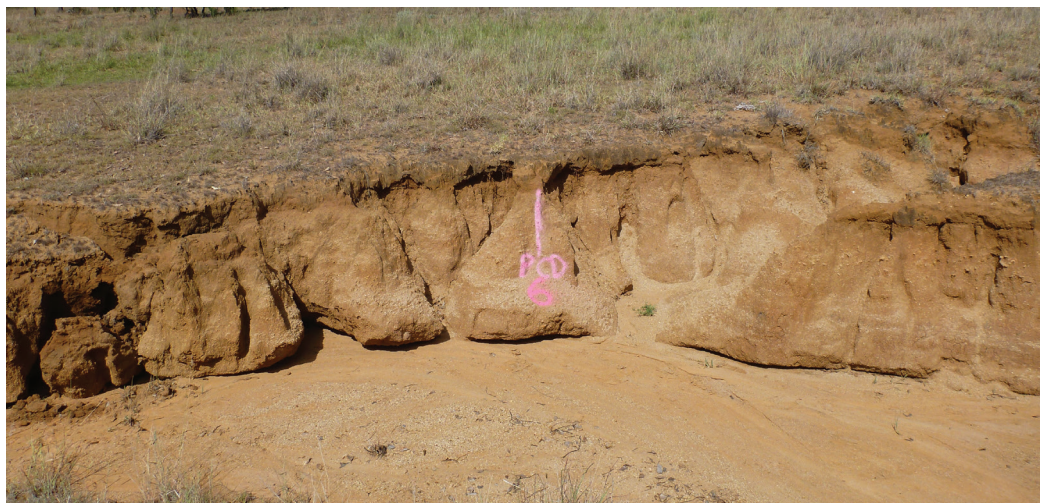
SITE 1 - BEFORE REMEDIATION WORKS

Before construction of a PCD.

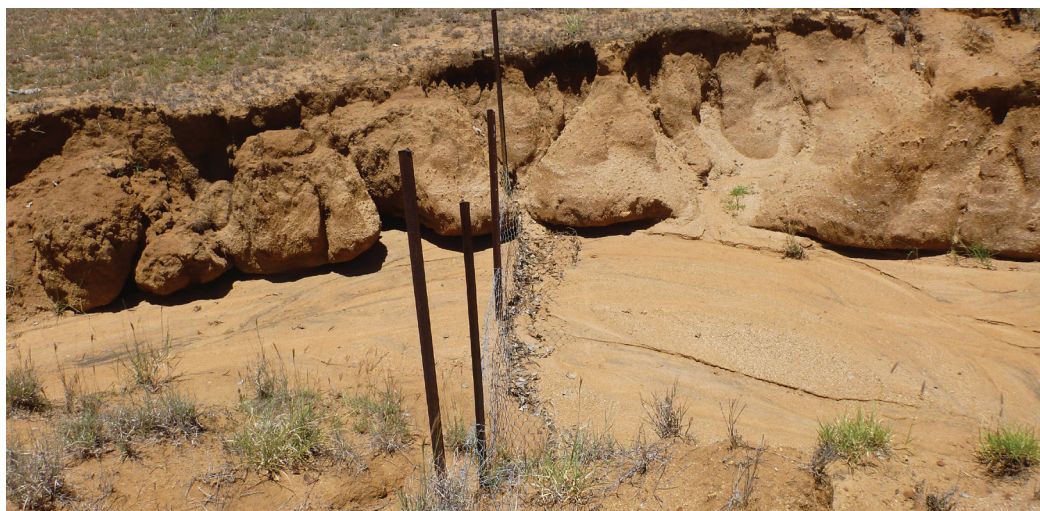
SITE 1 - AFTER REMEDIATION WORKS

2 weeks following construction the PCD at Site 1 is already collecting organic debris and sediments.
