Waterford — Isaac

Gully Erosion

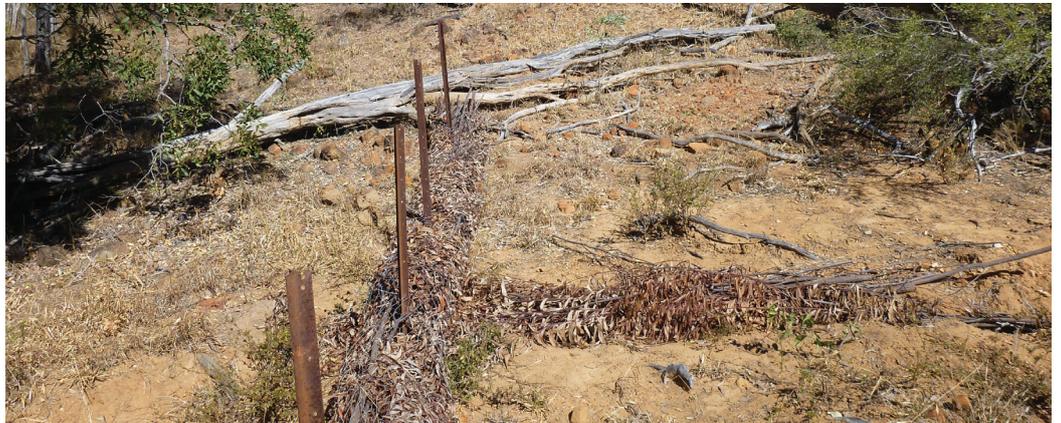
After fencing the area, Russell and Sheryl have constructed 30 Porous Check Dams (PCDs) across six gully sites based on *The Gully Toolbox* guidelines.

The point of porous check dams (PCDs) is to capture organic material such as leaf litter and seeds as well as sediment from the upstream catchment, creating a favourable environment for grass cover to establish over the gully floor.

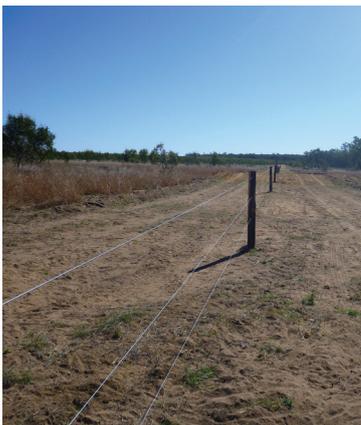
Three kilometres of fencing has been constructed to exclude cattle from gullied areas for at least three years.

As the fenced area now excludes cattle access to dams, an alternative watering trough was installed in a central, less erosion-prone part of the remaining improved pasture. At the same time, a second trough was set up at a stable site within the exclusion area, for future grazing when the area has sufficiently reestablished.

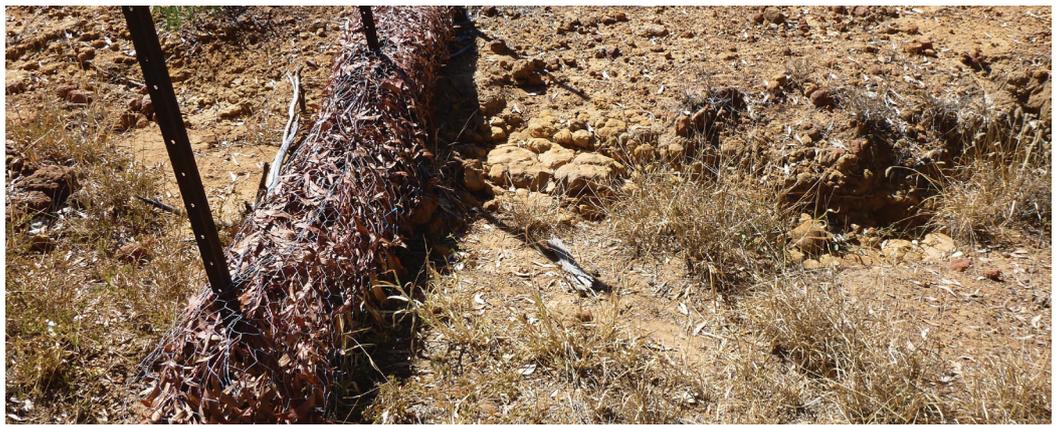
Some PCDs have been constructed with wattle suckers rather than sticks as suckers were more readily available in the vicinity.

Some PCDs have been constructed with wattle suckers rather than sticks as suckers were more readily available in the vicinity.
