## GEOTECHNICAL INVESTIGATION

Bank Stability Assessment  
Fitzroy River, Garnant

Report for: Alluvium Consulting Pty Ltd  
23332-002-Rev0  
29 November 2023

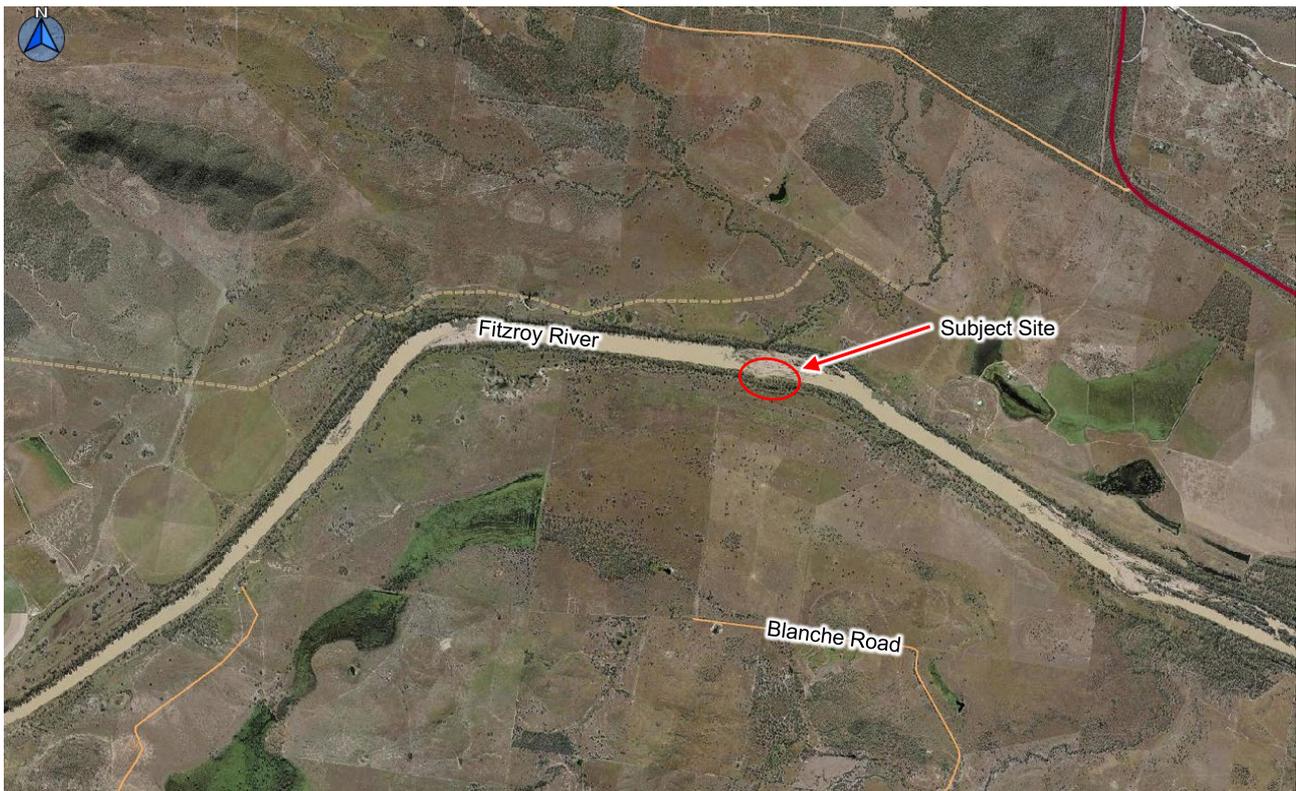
*Text Figure 1: 2021 aerial image of the site and surrounds (courtesy QGlobe imagery)*

The banks along the site featured a range of geometries, with significant evidence of erosion and previous bank slumping observed consistently, and debris fields present in multiple sections along the riverbed.

Generally, there was a near vertical upper bluff estimated to range between about 1 m and 7 m high developed beneath the crest, with slumped debris forming a lower bank estimated to range up to about 7 m high, which dipped into the river between about 35° and 45°. Materials exposed in the banks appeared to comprise mostly interlayered sandy clays and clayey sands. Irregular and overhanging crests were noted, with tension cracking observed behind the crest in the soil mass, which may cause the material to fail by 'sheeting off' the face and toppling from the crest. The overall height from the crest to the water surface was estimated to be in the order of about 14 m.

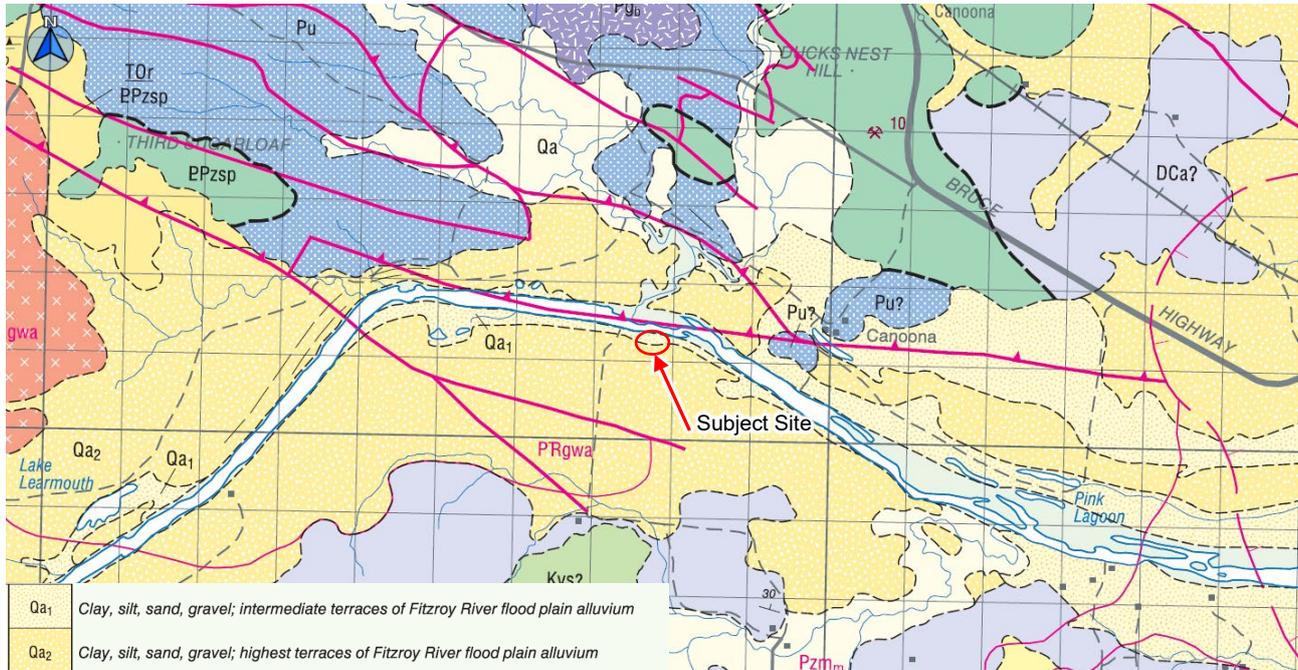
Text Figure 6: Extract of Ridgeland Surface Geology Map

The 1:100,000 scale Ridgeland Surface Geology Map (DNRME, Sheet 8951, dated March 2006) indicates that the site is located at an interface of Quaternary age intermediate and highest terraces of the Fitzroy River flood plain alluvium, both comprising 'clay, silt, sand and gravel'. An extract of the relevant geological map is shown in Text Figure 6.

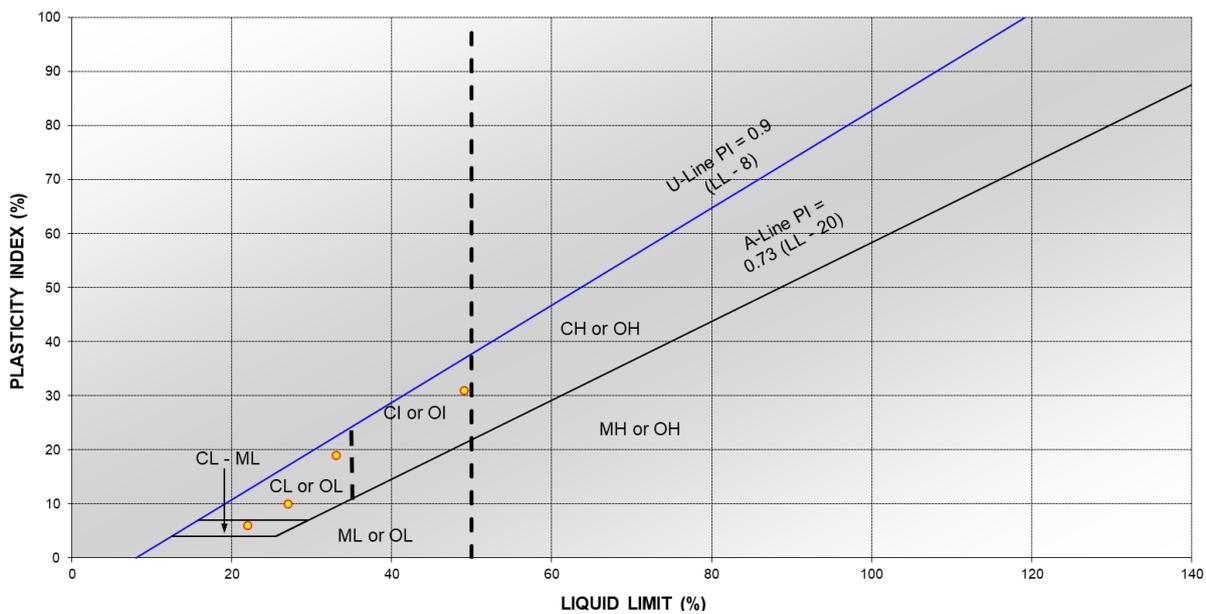
*Text Figure 7: Summary of Atterberg Limits Testing*

Laboratory testing indicates that the clays tested were of low to medium plasticity. PSD testing of the more clayey samples generally indicated the soils were silty/sandy clays with fine to medium grained sands. It is noted that the coarse-grained sample tested was a fine to coarse grained sand with low plasticity clay fines.

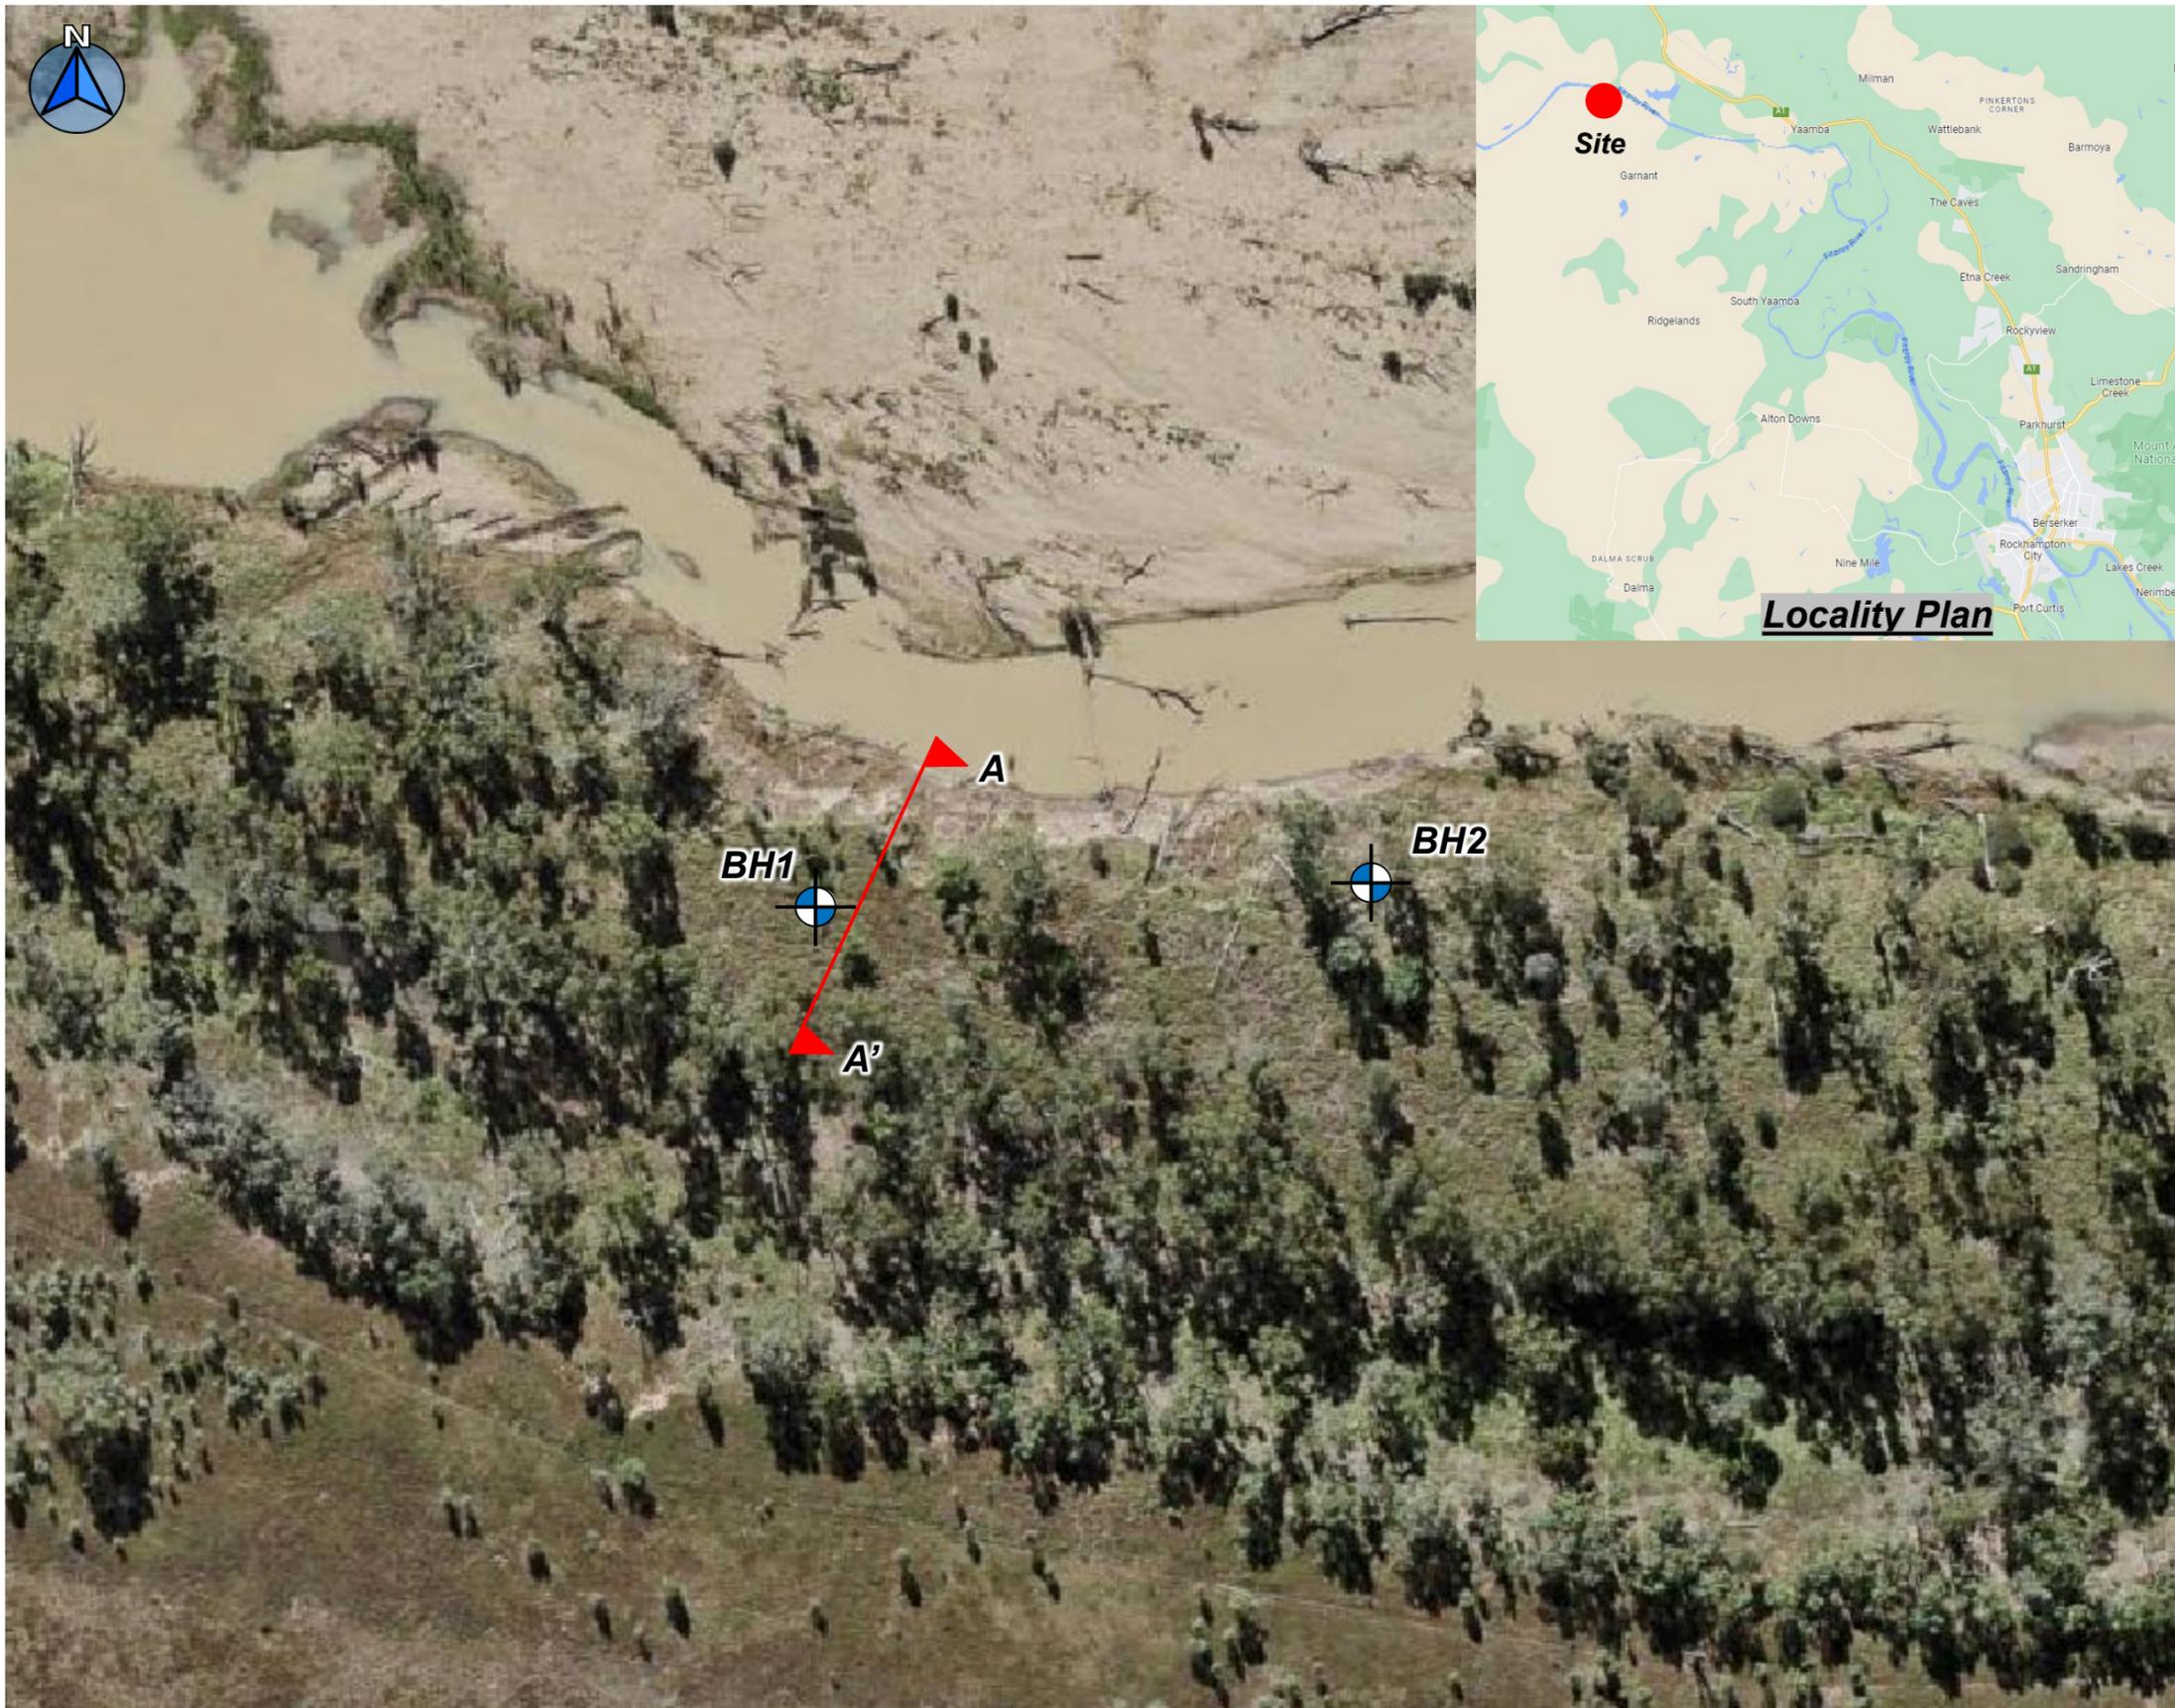
TITLE:  
**SITE PLAN**

A subsurface cross-section was developed in the area of borehole BH1 (Section A-A', ref. Figure 1) using the borehole information, along with the proposed ground surface profile advised by Alluvium. Some inferences regarding subsurface conditions have been made short distances away from test locations, and typically the more adverse ground conditions were adopted for the analysis.
